Effects of Magnetic Fields and Power Quality on CRTs... A Complex Investigation

S&C Featured Solution: S&C's Engineering Services

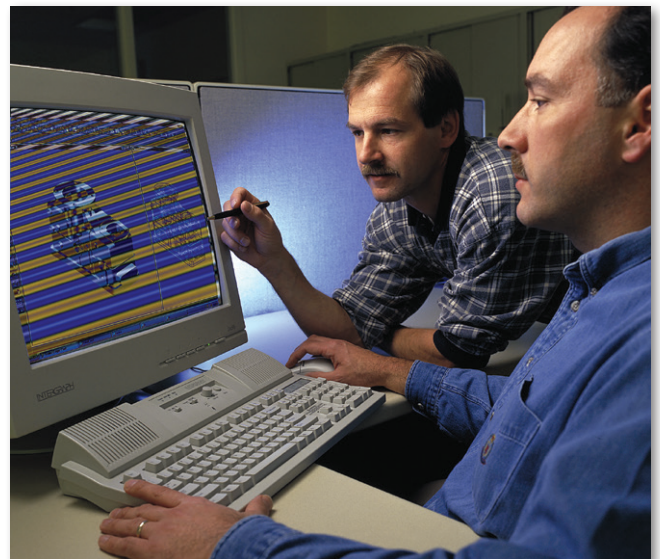
By testing the CRT monitors in conjunction with the bulk tape eraser, S&C ascertained that the flicker was caused by the combination of the low-magnitude magnetic field and the 60-Hz power frequency. This combination of factors interfered with the monitors, which had a screen-refresh scanning frequency setting of 76 Hz to reduce eyestrain. It was demonstrated that

by setting the screen refresh rate to match the power frequency, flicker was eliminated.

- The simplest solution proposed was to reset the screen refresh rate to 60 Hz. But this setting would cause eyestrain to users.
- Another solution proposed was replacement of the affected CRT monitors with LCD monitors. LCD monitors are not affected by magnetic fields.
- A third solution offered was to decrease the magnetic field strength. This option would be costly, however, and would require the use of special metal alloy shielding for the electrical service closet and/or the CRTs.
