### Condition of the Fuse Tube

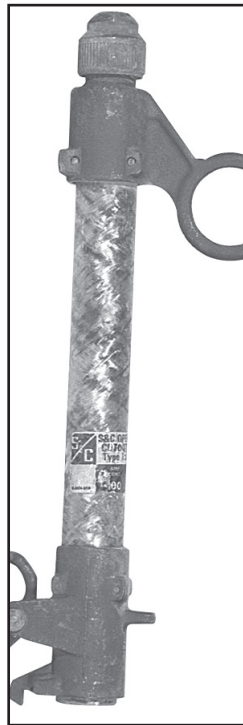
The exterior surface of the epoxy fiberglass fuse tube should be inspected for excessive weathering. If the gray polyurethane paint has completely faded so the underlying tube is visible, the condition of the fuse tube is still acceptable. However, the tube should be inspected more frequently. If, on the other hand, the paint has completely faded *and* the fiberglass fuse tube exhibits significant fraying or fuzzing, the strength of the tube may not be sufficient to withstand the internal pressures generated during fault-current interruptions. In this case, the fuse tube should be replaced. This is illustrated in Figures 1(a) through 1(c) for a typical 100-ampere fuse tube.

Figure 1(b). Acceptable:  
Paint is completely faded.

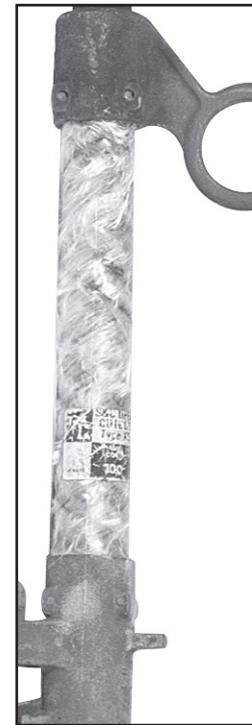
Figure 1(c). Replace:  
Fuse tube exhibits significant fraying.

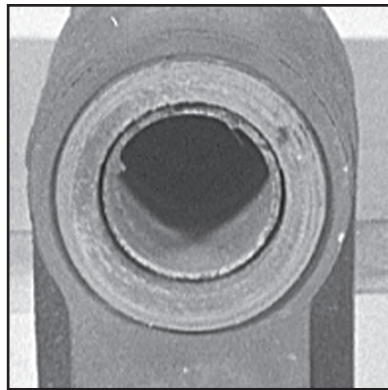
in the level of erosion, measure the diameter of the liner at two different points and record the larger of the two. If this diameter is greater than  $\frac{1}{16}$ -inch (17.5 mm) for a 100-ampere fuse tube, or 1 inch (25.4 mm) for a 200-ampere fuse tube, *the fuse tube should be replaced with a new fuse tube*. If the liner is chipped significantly or there is no liner material at the end of the fuse tube—*the fuse tube should be replaced with a new fuse tube*. This is displayed in Figures 2(a)-2(c) below.

Figure 2(b). Acceptable: Diameter of liner is less than  $\frac{1}{16}$ -inch (17.5 mm) for a 100-ampere fuse tube, or 1 inch (25.4 mm) for a 200-ampere fuse tube, and there is no significant chipping.

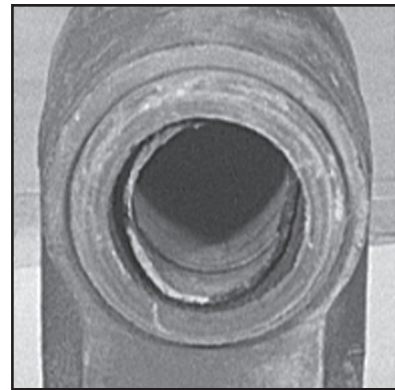
**Erosion and Chipping:** Each time the fuse cutout operates, arcing inside the fuse tube causes small amounts of the arc-extinguishing liner to erode, thereby increasing the inner diameter of the tube. After a number of operations—fewer in the case of high-magnitude faults—the liner may no longer be sufficient to properly extinguish the arc. Should the liner become too thin, the material may crack and chip away.

Figure 2(c). Replace: Diameter of liner is greater than  $\frac{1}{16}$ -inch (17.5 mm) for a 100-ampere fuse tube, or 1 inch (25.4 mm) for a 200-ampere fuse tube, and/or there is chipping or significant loss of liner material.

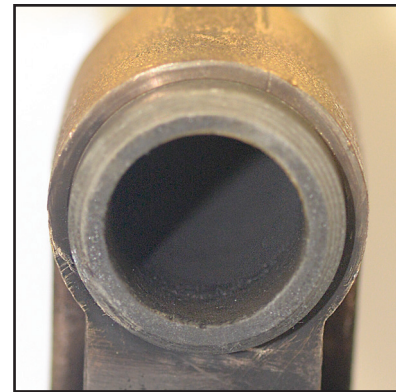
**Erosion and Chipping:** Each time the fuse cutout operates, arcing inside the fuse tube causes small amounts of the arc-extinguishing liner to erode, thereby increasing the inner diameter of the tube. After a number of operations—fewer in the case of high-magnitude faults—the liner may no longer be sufficient to properly extinguish the arc.

Wipe down the end of the fuse tube with a cloth to remove any excess dirt and debris. To account for small variations in the level of erosion, measure the diameter of the liner at two different points and record the larger of the two. If this diameter is greater than  $\frac{23}{32}$ -inch (18.3 mm) for a 100-ampere fuse tube, or 1 inch (25.4 mm) for a 200-ampere fuse tube, *the fuse tube should be replaced with a new fuse tube*. This is displayed in Figures 3(a) and 3(b) below.

Figure 3(b). Replace: Diameter of liner is *greater than*  $\frac{23}{32}$ -inch (18.3 mm) for a 100-ampere fuse tube, or 1 inch (25.4 mm) for a 200-ampere fuse tube.
