### Condition of the Fuse Tube

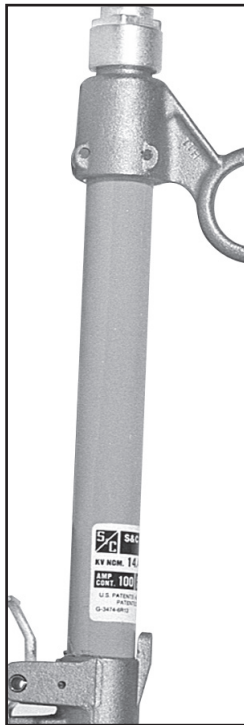
Figure 1(a). New.

The exterior surface of the epoxy fiberglass fuse tube should be inspected for excessive weathering. If the gray polyurethane paint has completely faded so the underlying tube is visible, the condition of the fuse tube is still acceptable. However, the tube should be inspected more frequently. If, on the other hand, the paint has completely faded *and* the fiberglass fuse tube exhibits significant fraying or fuzzing, the strength of the tube may not be sufficient to withstand the internal pressures generated during fault-current interruptions. In this case, the fuse tube should be replaced. This is illustrated in Figures 1(a) through 1(c) for a typical 100-ampere fuse tube.

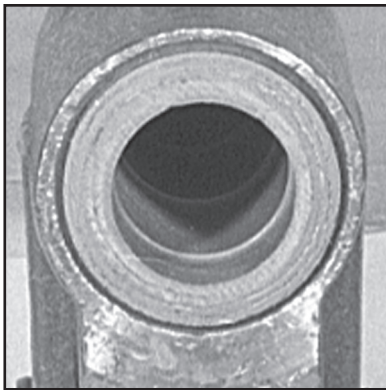
Figure 2(a). New.

**Erosion and Chipping:** Each time the fuse cutout operates, arcing inside the fuse tube causes small amounts of the arc-extinguishing liner to erode, thereby increasing the inner diameter of the tube. After a number of operations—fewer in the case of high-magnitude faults—the liner may no longer be sufficient to properly extinguish the arc. Should the liner become too thin, the material may crack and chip away.

in the level of erosion, measure the diameter of the liner at two different points and record the larger of the two. If this diameter is greater than  $\frac{1}{16}$ -inch (17.5 mm) for a 100-ampere fuse tube, or 1 inch (25.4 mm) for a 200-ampere fuse tube, *the fuse tube should be replaced with a new fuse tube*. If the liner is chipped significantly or there is no liner material at the end of the fuse tube—*the fuse tube should be replaced with a new fuse tube*. This is displayed in Figures 2(a)-2(c) below.

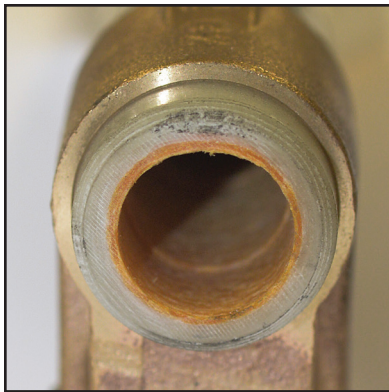
Figure 3(a). New.

**Erosion and Chipping:** Each time the fuse cutout operates, arcing inside the fuse tube causes small amounts of the arc-extinguishing liner to erode, thereby increasing the inner diameter of the tube. After a number of operations—fewer in the case of high-magnitude faults—the liner may no longer be sufficient to properly extinguish the arc.

Wipe down the end of the fuse tube with a cloth to remove any excess dirt and debris. To account for small variations in the level of erosion, measure the diameter of the liner at two different points and record the larger of the two. If this diameter is greater than  $\frac{23}{32}$ -inch (18.3 mm) for a 100-ampere fuse tube, or 1 inch (25.4 mm) for a 200-ampere fuse tube, *the fuse tube should be replaced with a new fuse tube*. This is displayed in Figures 3(a) and 3(b) below.
