Recloser and USB Transceiver Firmware Update

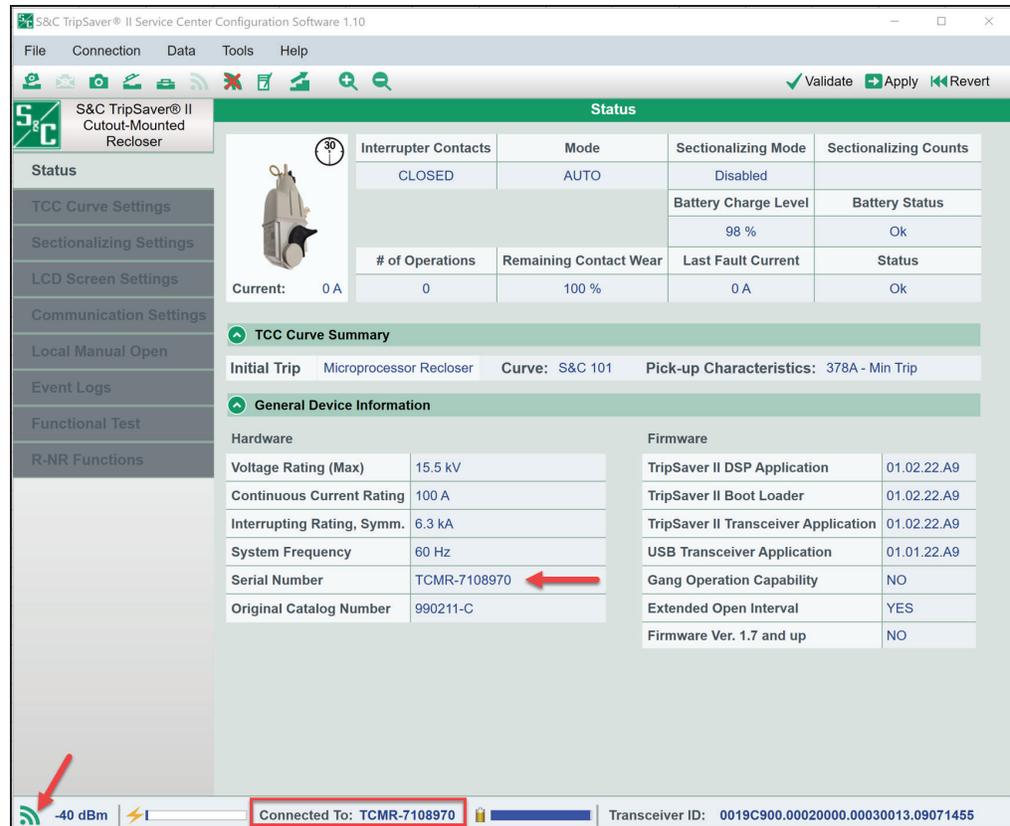
Figure 1. The TripSaver II recloser serial number and Signal Strength indicator locations.

- STEP 1.** Connect to the TripSaver II recloser with a computer loaded with service center configuration software v2.2, plug a USB transceiver into the USB port of the computer and attach the ac power module to the TripSaver II recloser.
- STEP 2.** Make a note of the serial number, starting with “TCMR,” of the TripSaver II recloser to be updated. See Figure 1 on page 10. This number is also etched on the body of the TripSaver II recloser.

STEP 3. Check that the **Signal Strength** indicator on the left side of the Additional Information Bar is green. The **Signal Strength** indicator provides information on the quality of the communication. It uses four different icons to indicate different signal strength levels:

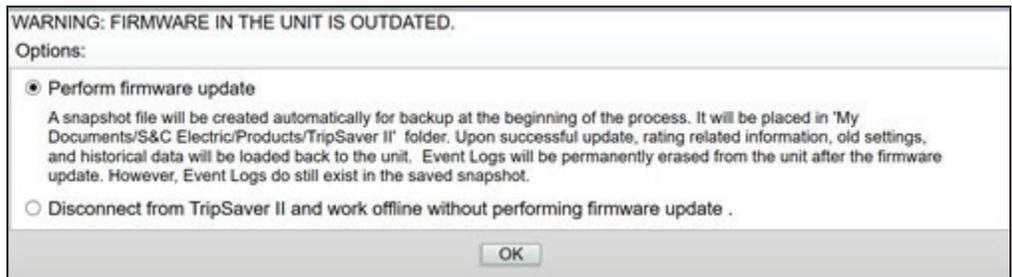
Figure 2. The firmware update Warning dialog box.

STEP 5. Select the **Tools>Firmware Update** option from the **Main** menu, or click on the Firmware Update icon in the quick access toolbar. If the firmware is out of date, a dialog box will appear. See Figure 2.

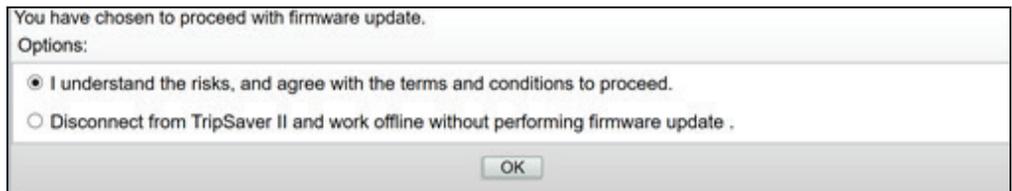
Figure 3. The firmware update Terms and Conditions dialog box.

STEP 7. A second dialog box will open. See Figure 3. Agree with the terms and conditions by selecting the appropriate option. Then, click on the **OK** button. To abort the firmware update, select the **Disconnect from the TripSaver II and work offline without performing firmware update** option and click on the **OK** button.

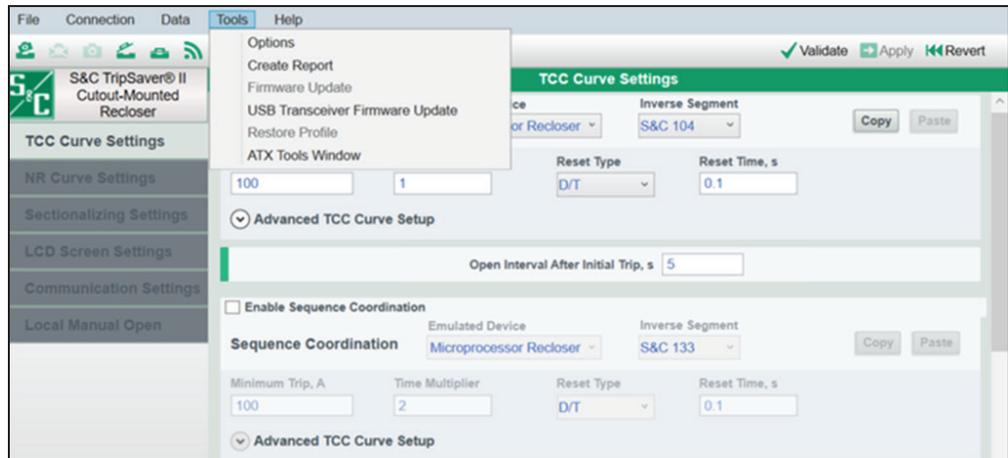
Figure 7. USB Transceiver Firmware Update menu item under the Tools menu.

- STEP 2.** Select the **Tools>USB Transceiver Firmware Update** option from the **Main** menu. See Figure 7.

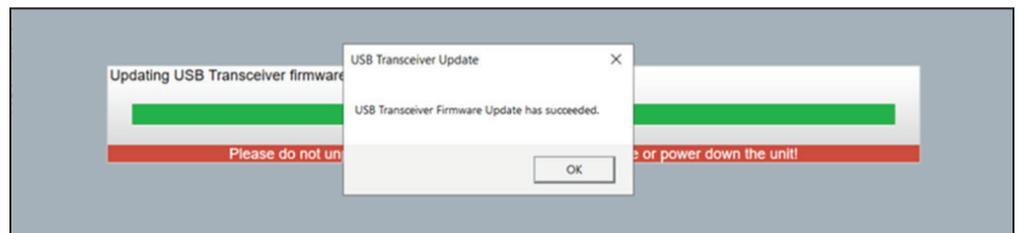
Figure 10. The USB transceiver firmware update success message.

STEP 4. When the update is complete, a dialog box will appear displaying a success message. Click on the **OK** button. See Figure 10.

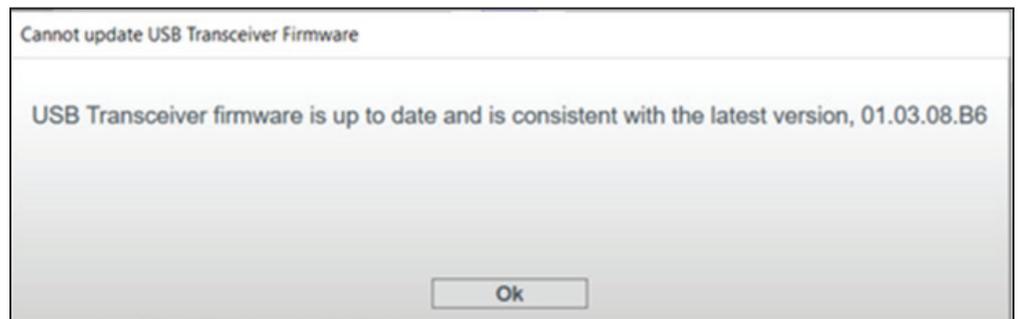
Figure 11. The Cannot update USB Transceiver Firmware dialog box.

Note: If the USB transceiver is up to date, the dialog box in Figure 11 will appear.

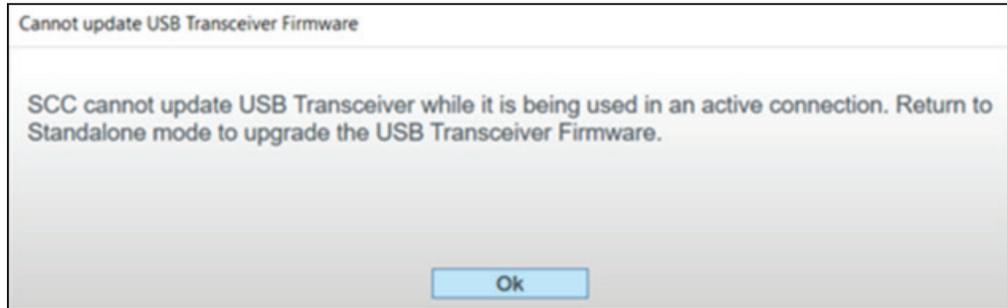
Figure 12. The Cannot update USB Transceiver Firmware dialog box when service center configuration software is in Connected mode.

Note: If the service center configuration software is in **Connected** mode (communicating with a TripSaver II recloser) the dialog box shown in Figure 12 will appear. The **USB Transceiver Firmware Update** procedure can only be completed in **Standalone** (offline) mode.

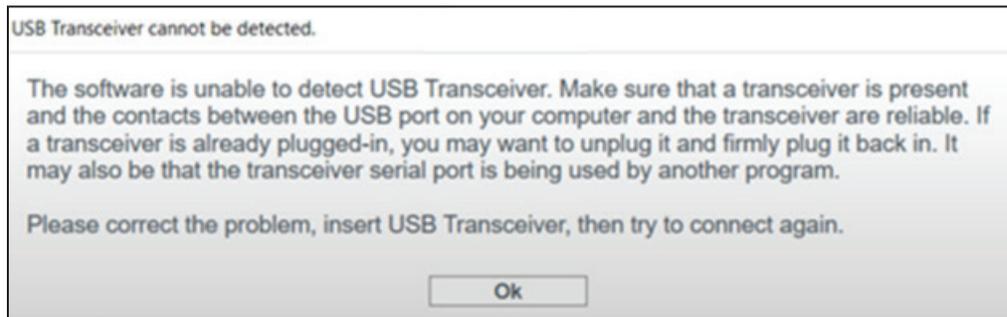
Figure 13. The USB Transceiver cannot be detected dialog box.

Note: If the service center configuration software is unable to detect the USB transceiver, unplug it and plug it back in. If it's still not working, try a different USB port on the computer. See Figure 13.

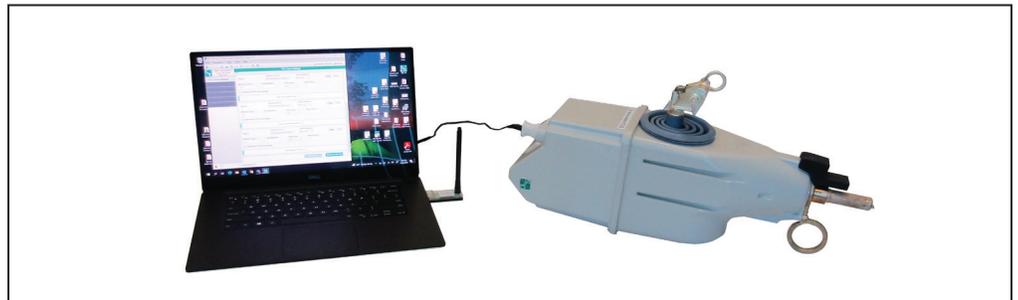
Figure 14. Placement of the TripSaver II recloser in relation to the USB transceiver.

Having a low signal strength between the TripSaver II recloser and the USB transceiver can cause delays in updating settings and extended firmware update times. If experiencing low signal quality when connected to a TripSaver II recloser using the USB transceiver and the service center configuration software, move the powered TripSaver II recloser between one to 4 inches (25 to 102 mm) away from the USB transceiver, with the recloser facing down, the trunnion pointing up, and with the LCD screen toward the USB transceiver at an approximate 45° angle. See Figure 14.

Service center configuration software version 2.2x in combination with the USB transceiver with enhanced antenna (part number FDA-1868R2) significantly improves signal strength.

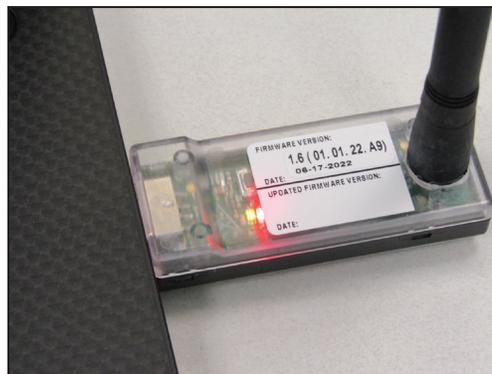
Figure 15. LED indicators on the USB Transceiver.

Table 4 on page 18 details the USB transceiver's LED indicators and their meaning. See Figure 15.

LED Indicators	Condition
Green (constant)	Power is on.
Red (fast-blinking)	The USB transceiver is transmitting data. Fast-blinking during the connecting stage indicates the connection is successful and about to complete.
Red (slow-blinking)	The USB transceiver is attempting to connect to a TripSaver II recloser.
Red (Constant)	USB transceiver is in the Error state. If the red LED is on constantly, the USB transceiver should be reset. (See the "If the Connection Process Displays a Timeout Message" section for directions on how to reset the USB transceiver.)

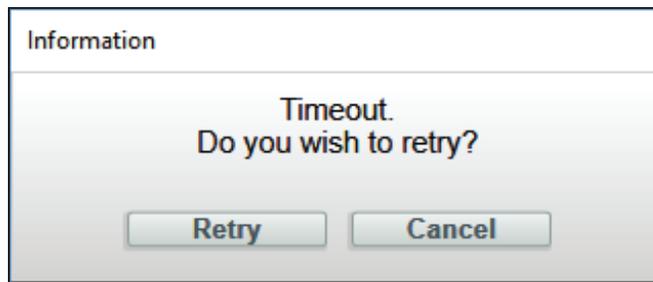
Figure 16. The timeout message.

When attempting to connect a TripSaver II recloser using the service center configuration software, the connection process will timeout if it is unable to create or maintain a wireless connection. See Figure 16. This is generally caused by low signal strength, which can be a result of distance, orientation of the product, interference from other signal sources, or a combination of these. A USB Transceiver is available with an enhanced external antenna to improve signal strength.

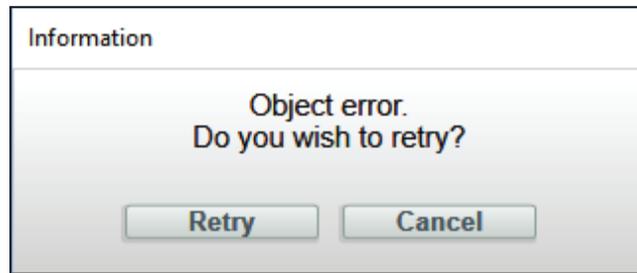
Figure 17. Object error message.

STEP 3. Reattempt connecting to the TripSaver II recloser. If the Timeout message (see Figure 16 on page 18) persists or an **Object Error** message (see Figure 17) appears, (this may be noticeable more often when connection to consecutive TripSaver II reclosers using the same computer), reset the USB transceiver.

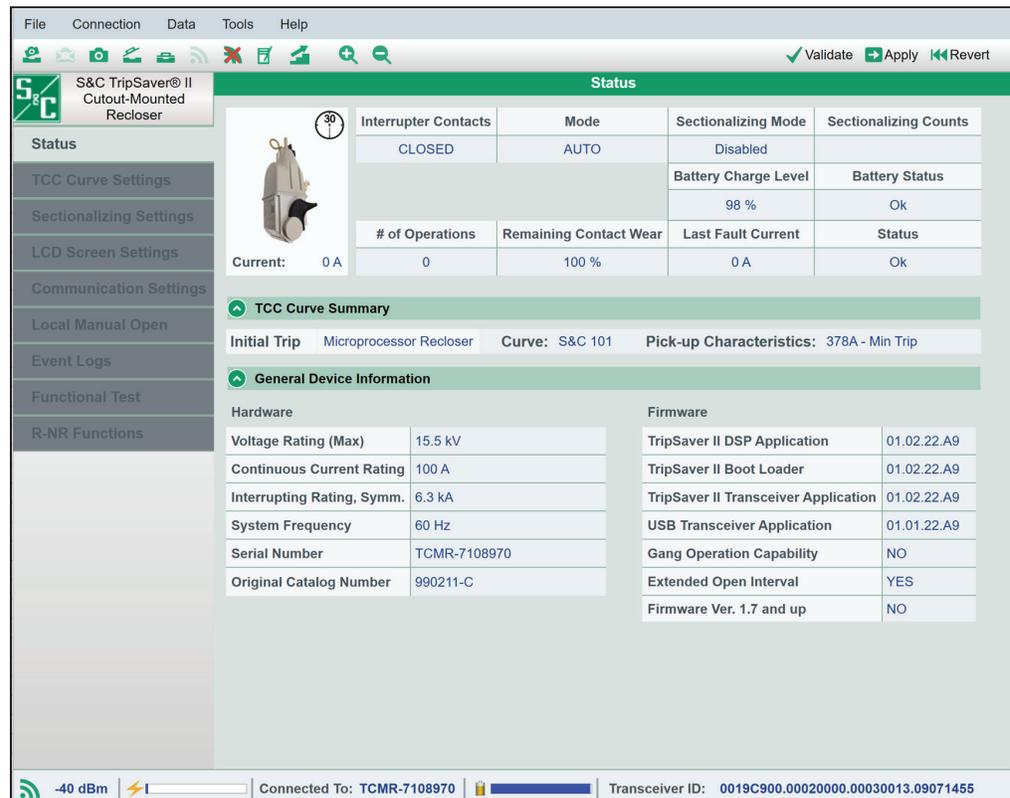
Figure 18. A TripSaver II recloser profile before a firmware update.

An example *Status* screen of a profile before and after data loss is shown in Figure 18 and Figure 19 on page 21.

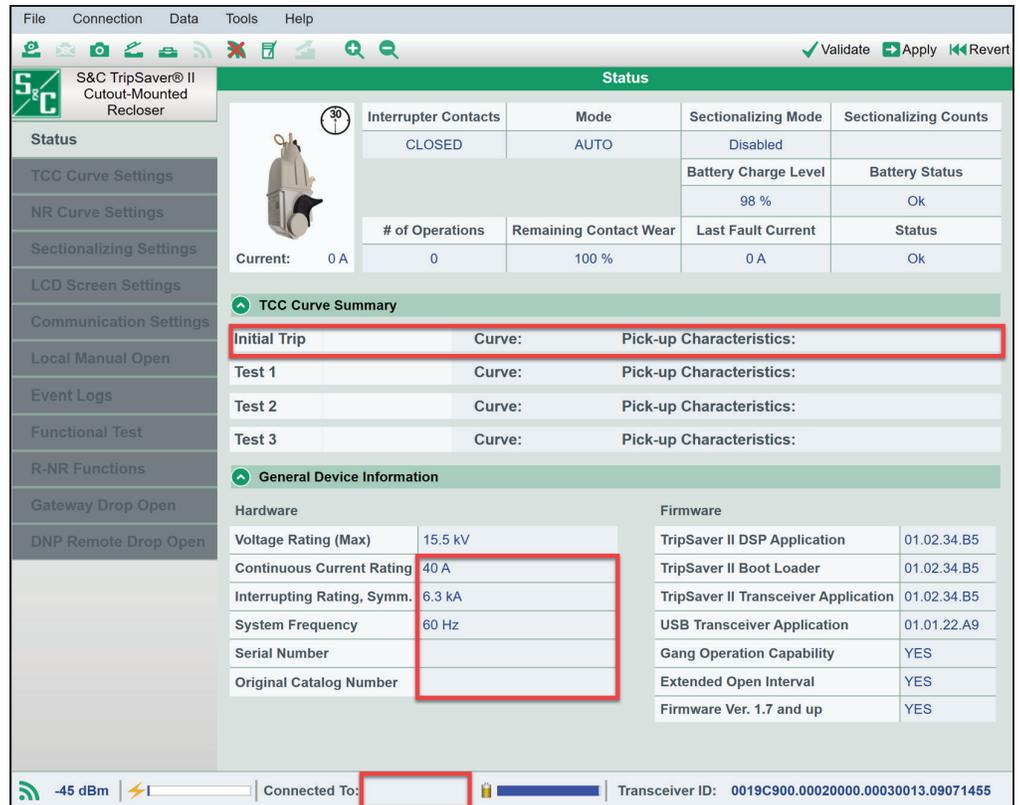
Figure 19. A TripSaver II recloser profile after profile data has been lost. Lost settings are noted within the red boxes.

TripSaver II reclosers that have experienced connection issues during a firmware update may lose their profile data. This can include serial number information, catalog number information, all programmed settings, and an incorrect continuous current rating. This condition can occur when:

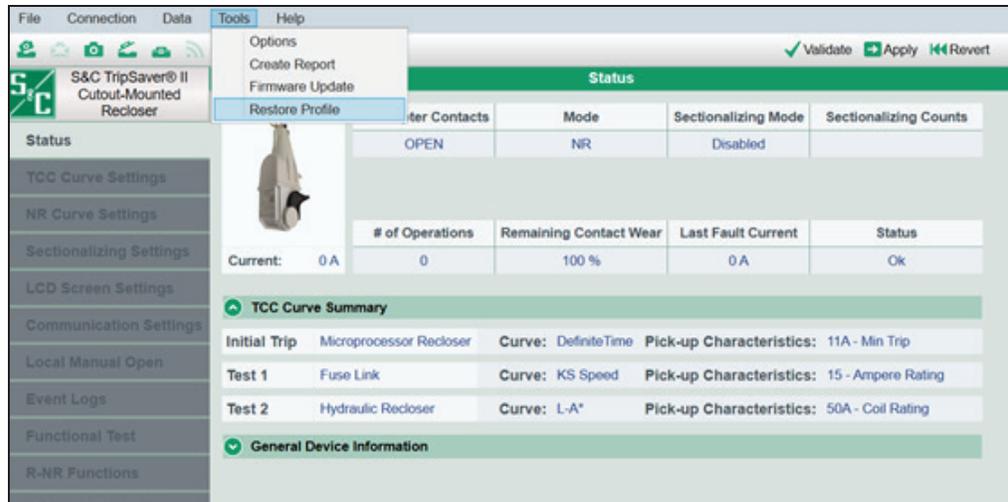
Figure 20. The Restore Profile menu item in the Tools menu.

- STEP 1.** Download and install SCC 2.2 software on the laptop.
- STEP 2.** Launch SCC 2.2 software and connect to the TripSaver II recloser.
- STEP 3.** Navigate to **Tools>Restore** menu item.

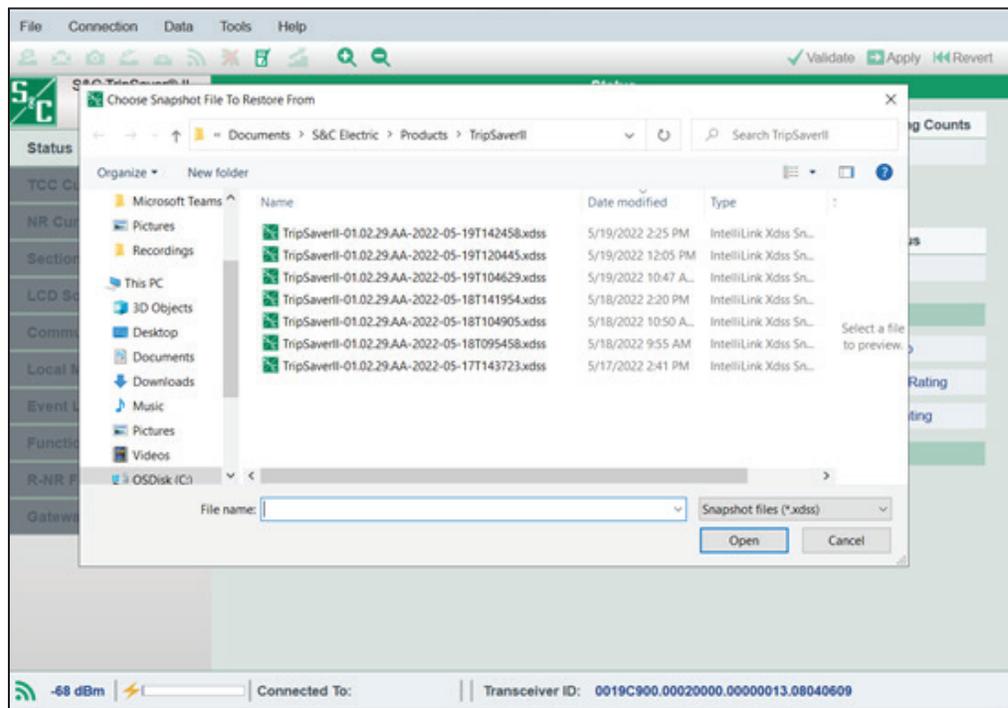
Figure 21. Snapshot files in the Documents>S&C Electric>Products>TripSaver II folder.

STEP 4. When prompted, navigate to the snapshot (.xdss) file in the Documents>S&C Electric>Products>TripSaver II folder and choose the most recent snapshot file having the TCMR number matching the TripSaver II recloser being restored.

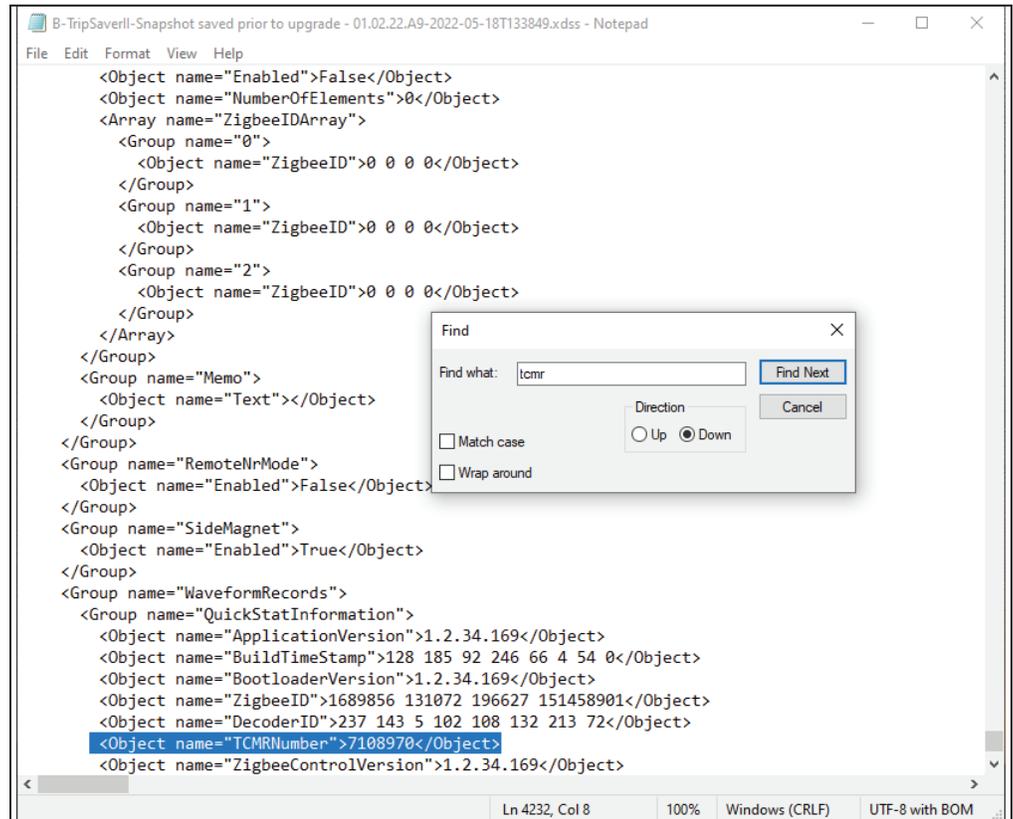
Figure 22. The Snapshot file opened with Notepad.

Note: If the firmware update was done with service center configuration software version 1.9 or earlier, S&C recommends opening the snapshot (.xdss) file in Microsoft Notepad to determine whether the TCMR number in the snapshot file matches the TCMR etched on the TripSaver II recloser being restored. (The serial number for the TripSaver II recloser (TCMR-) is etched on the recloser housing.) It is important not to alter the snapshot file when opened because doing so may have an adverse impact on the restoration process.

To check the snapshot file using Notepad: Navigate to the *Documents>S&C Electric>Products>TripSaver II* folder. If several TripSaver II reclosers have been updated, more than one snapshot file could be in this folder. Open the snapshot file using Microsoft Notepad. From the **Edit** menu, select the **Find** menu item and search for “TCMR.” Match this to the TripSaver II recloser to which the profile data is to be restored. See Figure 22. Close the snapshot file without saving any changes.

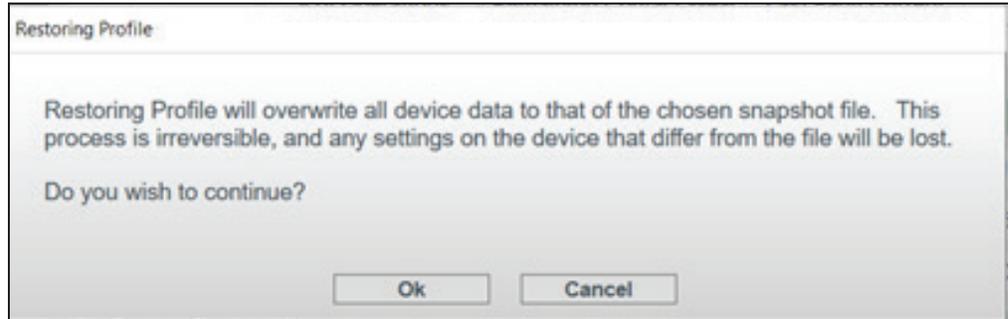
Figure 23. The Restoring Profile dialog box.

STEP 5. After selecting the snapshot file, the Restoring Profile dialog box will open. Click on the **OK** button. A **Success** message will appear when the profile restoration is complete. See Figure 23.

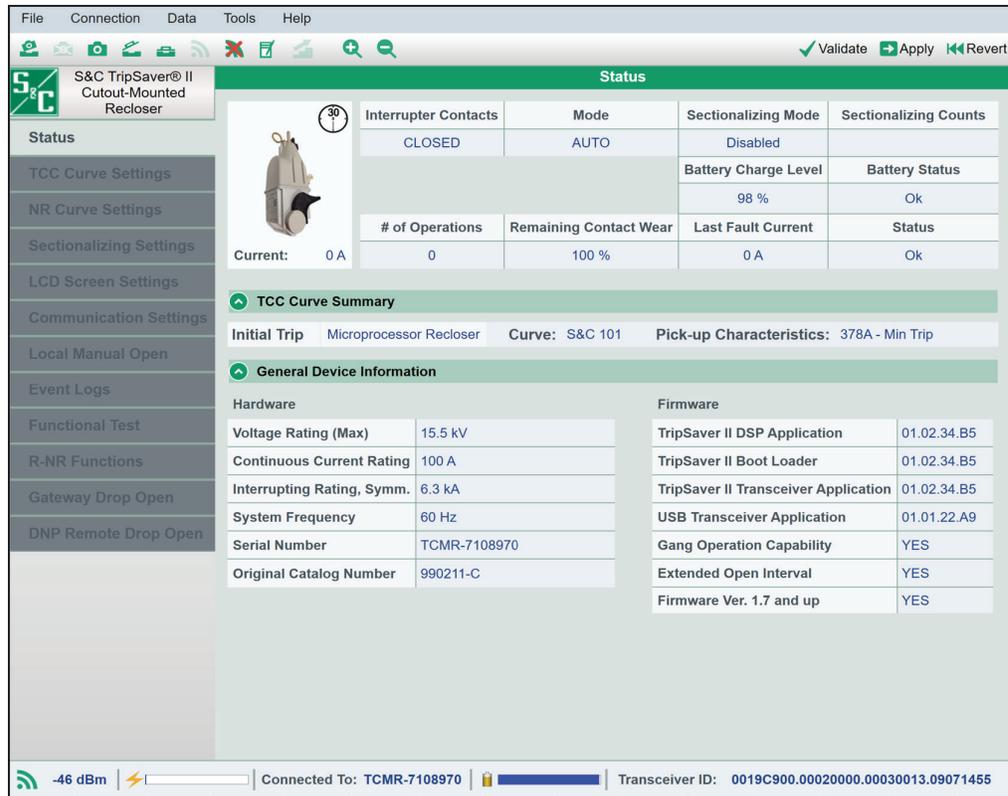
Figure 24. The Status screen after a successful profile restoration.

STEP 6. Check the *Status* screen to make sure the profile information has been successfully restored. See Figure 24.
