A Unique Solution to a Refinery's Power Quality Problems

S&C Featured Solution: Engineering Services

Location: Canada

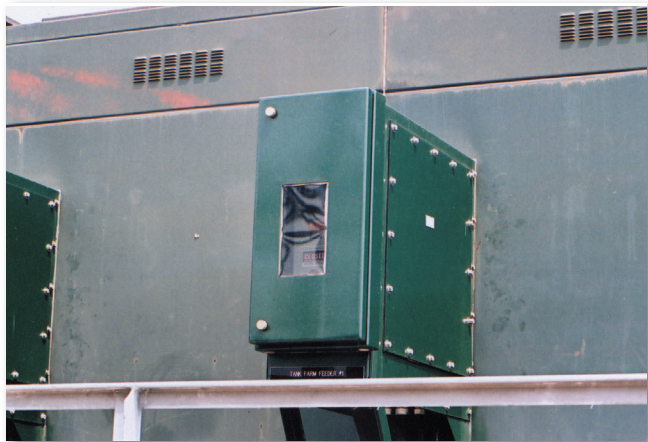
Upon learning of the dilemma through the refinery's consultant, S&C proposed a turnkey solution wherein the 10 feeder bays of the switchgear would be modified to allow automatic switch operation upon sensing low-level fault currents. It would involve the installation of current transformers, ground fault relays, and motorized switch operators into bays that were not originally designed to accept them.

Because there was insufficient room on the stile of each feeder bay to incorporate a motorized switch operator, a special design was developed in which the operator would be mounted behind the switch on the outside of the gear. Each operator would be connected to its associated switch using a chaindrive. A combination mounting bracket/sheet-steel cutting template would be installed prior to the shutdown, ensuring proper alignment of the drive and significantly reducing the duration of the outage.

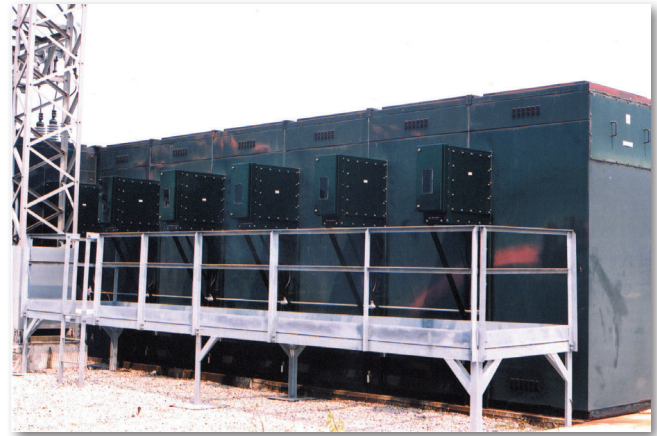
With each key team member well aware of the required methods and goals—and with all other members having been assigned a particular responsibility—the procedure went off like clockwork. The refinery was able to reenergize the gear at about 5:00 p.m., one hour before the scheduled completion time.
